Project No. 11844.G
March 31, 2008

Subject: **Preliminary Geologic Hazards Evaluation**
Proposed Residential Construction
Quarry Village
Carlos Bee Boulevard
Hayward, California

PRELIMINARY GEOLOGIC MAP

QUARRY VILLAGE
 HAYWARD, CALIFORNIA

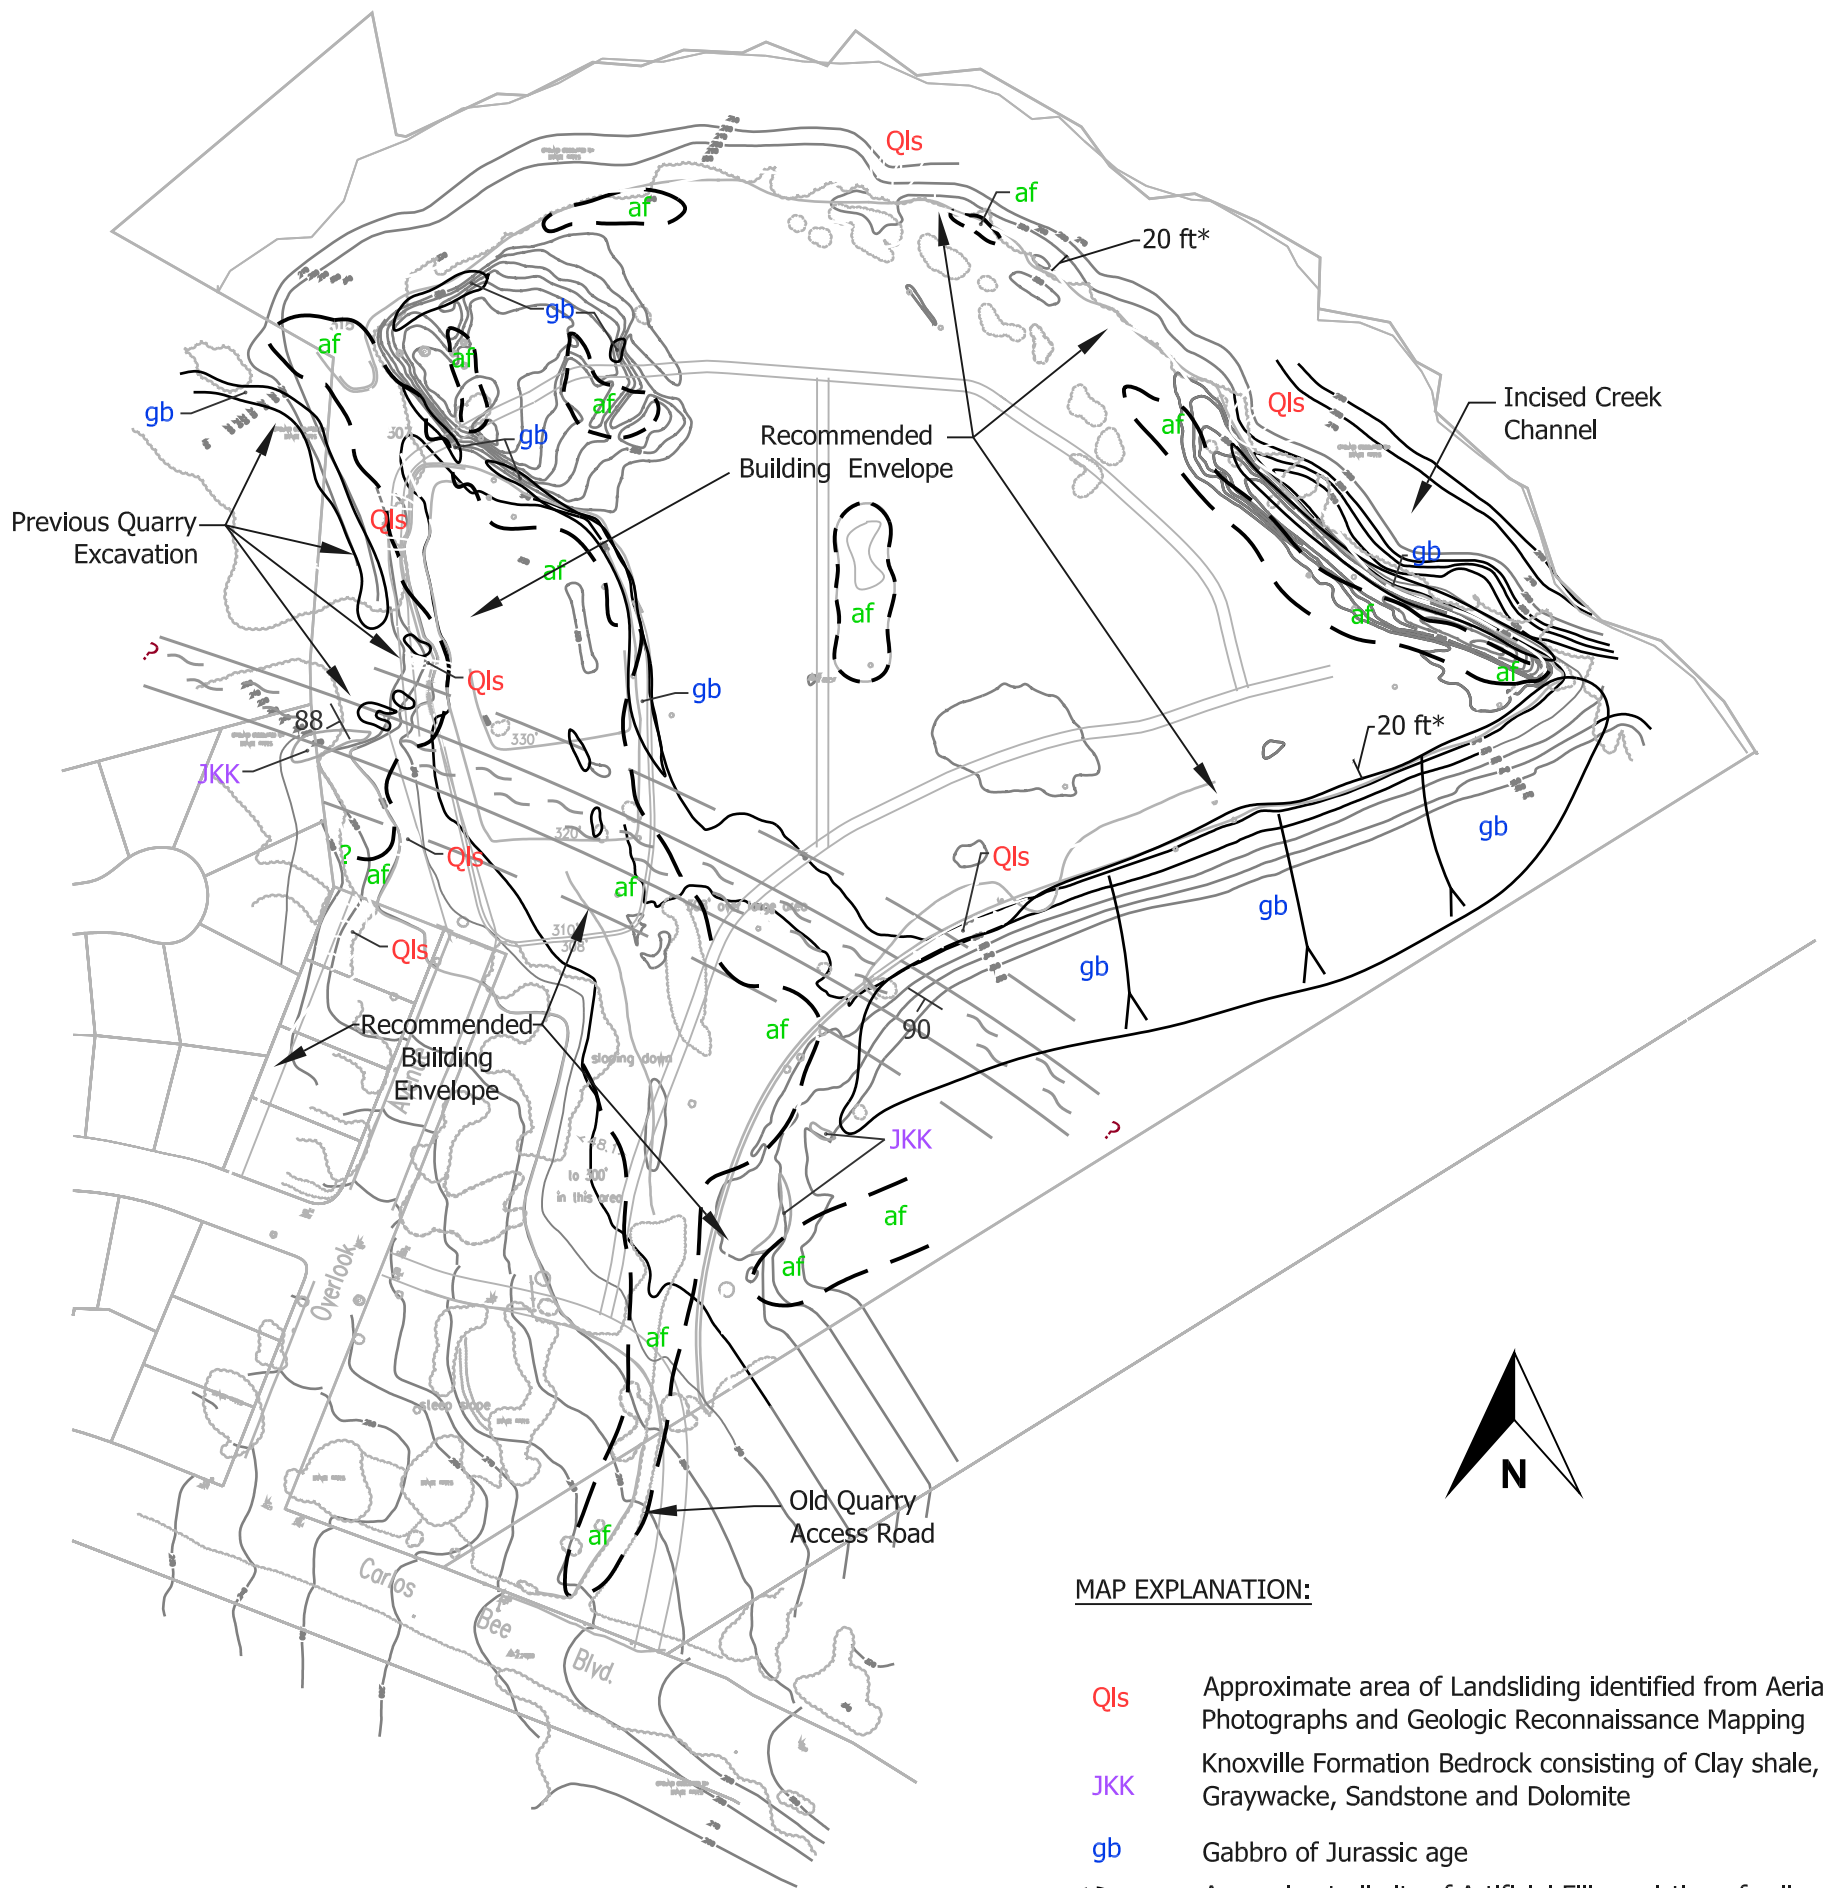
briefly visited the site to generally map the exposed geology. The results of our research and site observations are plotted on the Preliminary Geologic Map of Figure 2.

There are scattered pockets and berms of artificial fill throughout the site. Fill berms appears to have been created around the west side of the quarry operation. Some of the fill seems to have spilled over the side slopes and accumulated along the lower slopes adjacent to the residential developments at the end of Overlook Avenue and at the end of Tamalpais Place, based on our review of aerial photographs. A significant fill berm has been placed along the upper portion of the large cut slope at the southeast portion of the site. Another significant fill area exists along the downslope side of the old quarry access road in the south portion of the site (see Figure 2).

However, we have mapped several small landslides along the north and west fringes of the property from our geologic reconnaissance and from our review of aerial photographs (see Figure 2). These relatively small failures are within the fill areas along the west side of the property and along the steep-sided creek bank along the north side of the property.

An unnamed northwest striking fault has been mapped as passing through the site (Dibblee, 1980 and 2005; and Graymer and others, 1996). This fault generally separates sedimentary rocks on the south from igneous rocks on the north as discussed in the Bedrock Section of this report. From our analysis of pre-development aerial photographs we have identified a linear geomorphic break in the natural slope cutting across the central portion of the site in approximately the same general location as the previously mapped fault. This linear feature coincides with the mapped trace of the unnamed fault. Our brief geologic reconnaissance at the site suggests that the fault consists of a relatively wide zone of deformation that is steeply inclined or vertical. Further geologic mapping and subsurface exploration is needed to determine the actual location and activity of the fault.

- An unnamed fault has been mapped as passing through the site as shown on Figure 2 (Dibblee, 1980 and 2005; and Graymer and others, 1996). This fault has not been designed by the State Geologist as being seismically active (Hart and Bryant, 1997). However, secondary movement could occur along the fault during an earthquake on a nearby fault. A detailed fault evaluation study should be performed to investigate this fault.

- The approximately 150-foot high, northwest-facing bedrock cut slope along the southeast portion of the site is the result of past quarry operations. This cut slope does not comply with currently acceptable graded slope standards, such as maximum slope angle and drainage benches. This slope is likely prone to generate rock falls and the slope may be susceptible to landsliding during a seismic event (State Geologist, 2003). Global and surficial stability analyses of the slope should be performed.

- There are other oversteepened slopes that surround the site that also do not comply with currently acceptable graded slope standards. Some of these slopes already exhibit small landslides. The majority of the slopes in the west and northwest portion of the site may be susceptible to landsliding during a seismic event (State Geologist, 2003). Stability analyses of these slopes should be performed.

Without the benefit of performing any subsurface exploration or laboratory tested of soil and rock materials at the site, we have developed some building envelope recommendations that should be considered preliminary at this time. We recommend that any proposed construction at the site be set back from ascending and descending slopes resulting in accordance with Uniform Building Code Section 1344, and set back from the mapped trace of a major fault. These preliminary recommendations are generally stated below graphically shown on Figure 2.

- Construction set back of a minimum of 20 horizontal feet from the top of descending slopes with maximum steepness of 2:1 (Horizontal to vertical).
- Construction set back of 50 horizontal feet along both sides of the approximate location of the major fault that has been mapped as passing through the southwest portion of the site.
